ULVERSTON CANAL STRAIN GAUGES

Strain Gauge Monitoring Summary Q1 2023

Cadent Gas Limited

Report No.: 10428658/01, Rev. A

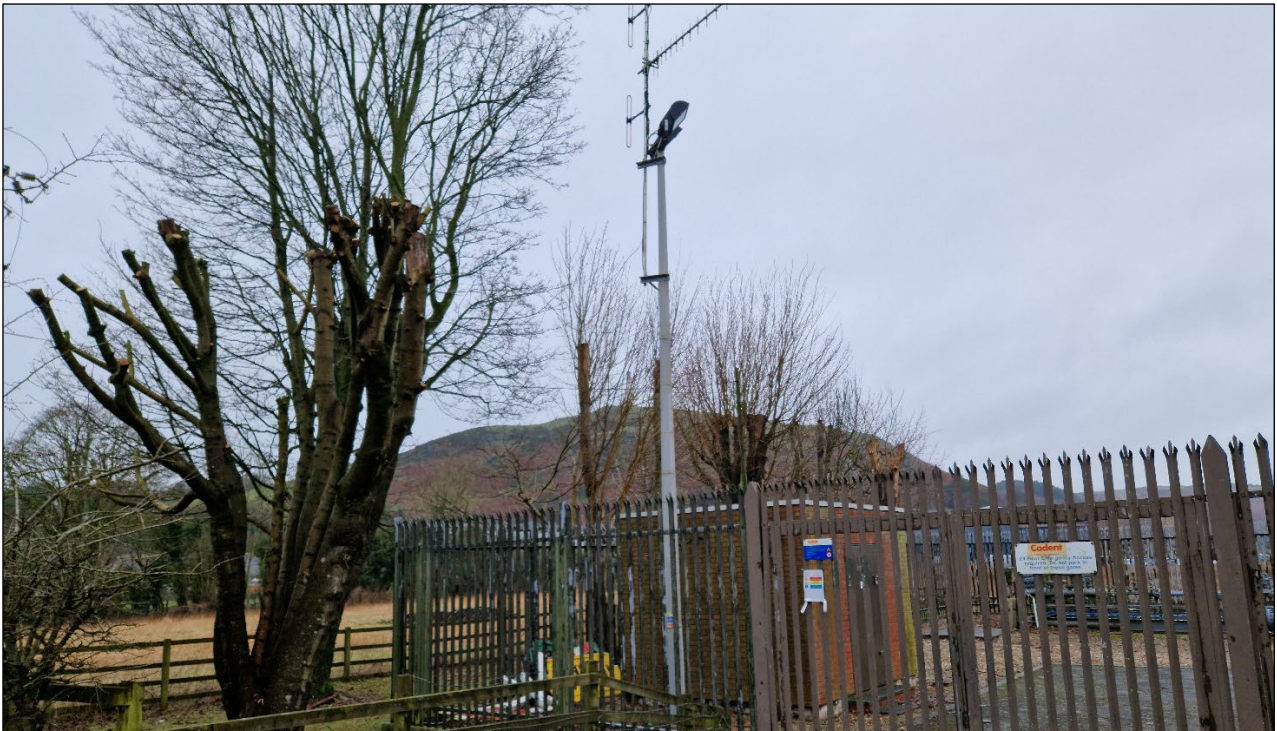
- Tree growth around the AGI (including trees close to the eastern fence) which will require ongoing management; although it was observed that the trees had previously been subjected to pollarding (See Figure 3-1).

Figure 3-1 Trees around the AGI which had previously been cut back, showing re-growth

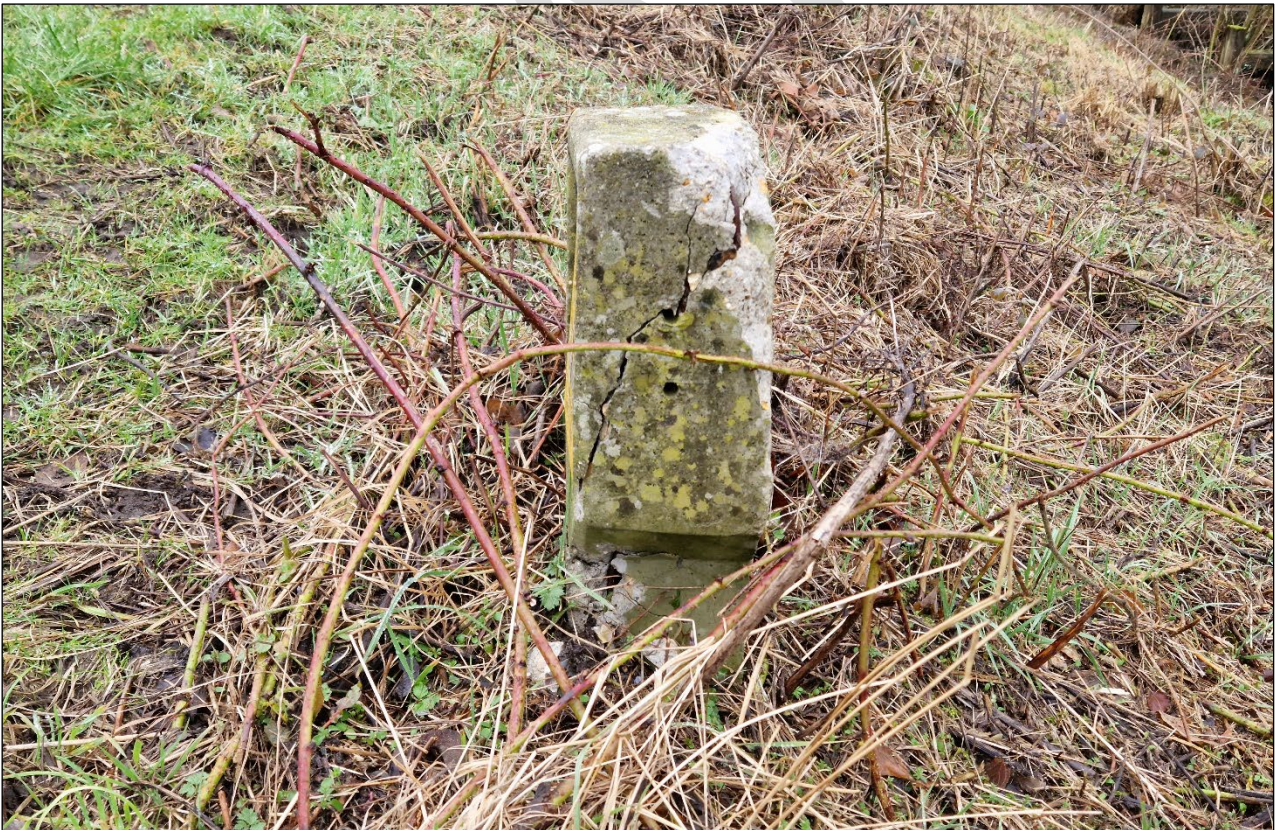
- Marker posts along the embankment appear to have been cosmetically damaged, probably as part of the vegetation clearance (See Figure 3-2). There is a risk that if the posts become too damaged from repeated interference, the connections to the strain gauges could also become damaged.

Figure 3-2 Damage to one of the CP posts containing the strain gauge connections, possibly caused by impact from cutting back equipment

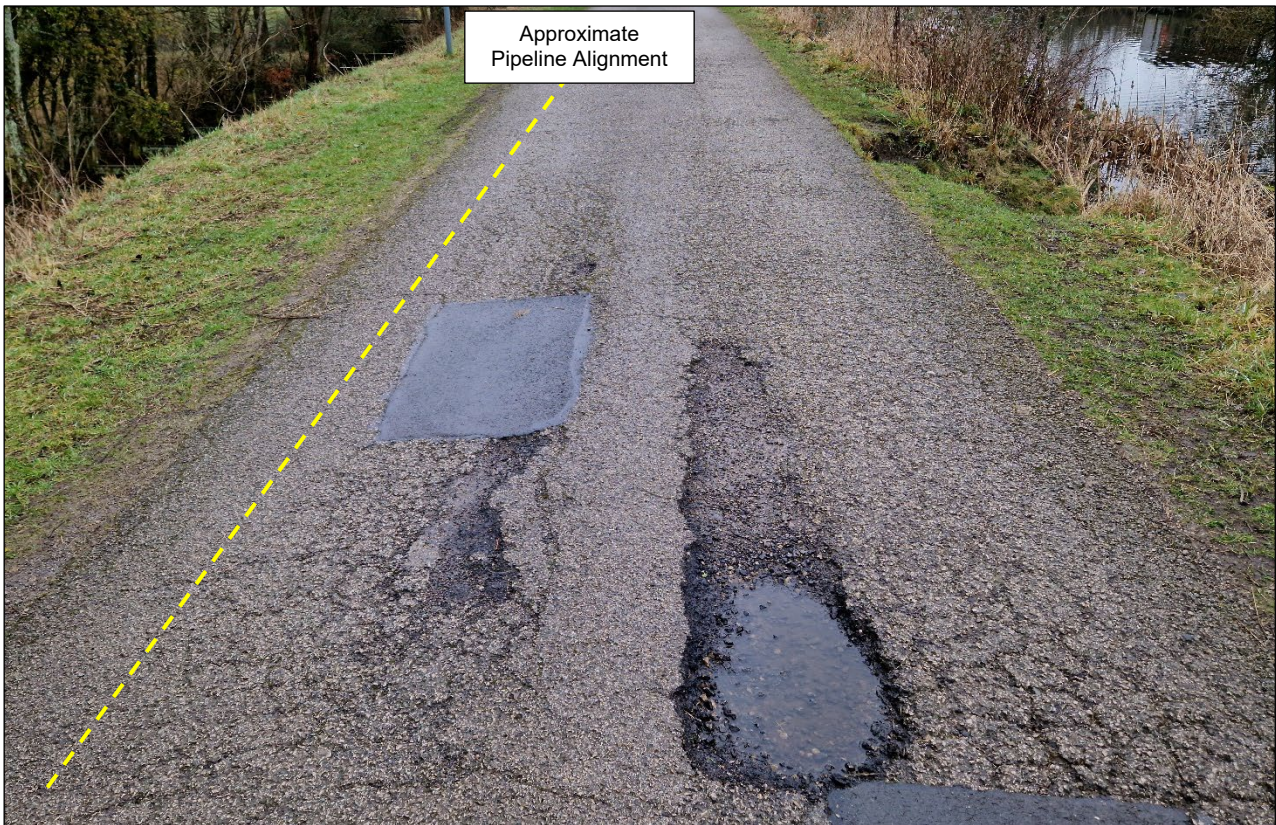
- Vehicles were noted driving at speed along the footpath/road which could contribute to compaction of the underlying soil – this was observed through increased cracking / wear / rutting of the road surface, including holes in the region of 36 cm diameter and greater (See Figure 3-3). Some of the rutting observed was also along the alignment of the pipeline (See Figure 3-4) and was present within previous site visits, but ongoing degradation cannot be discounted.

Figure 3-3 Evidence of continuing degradation of the road surface, including some surface depressions

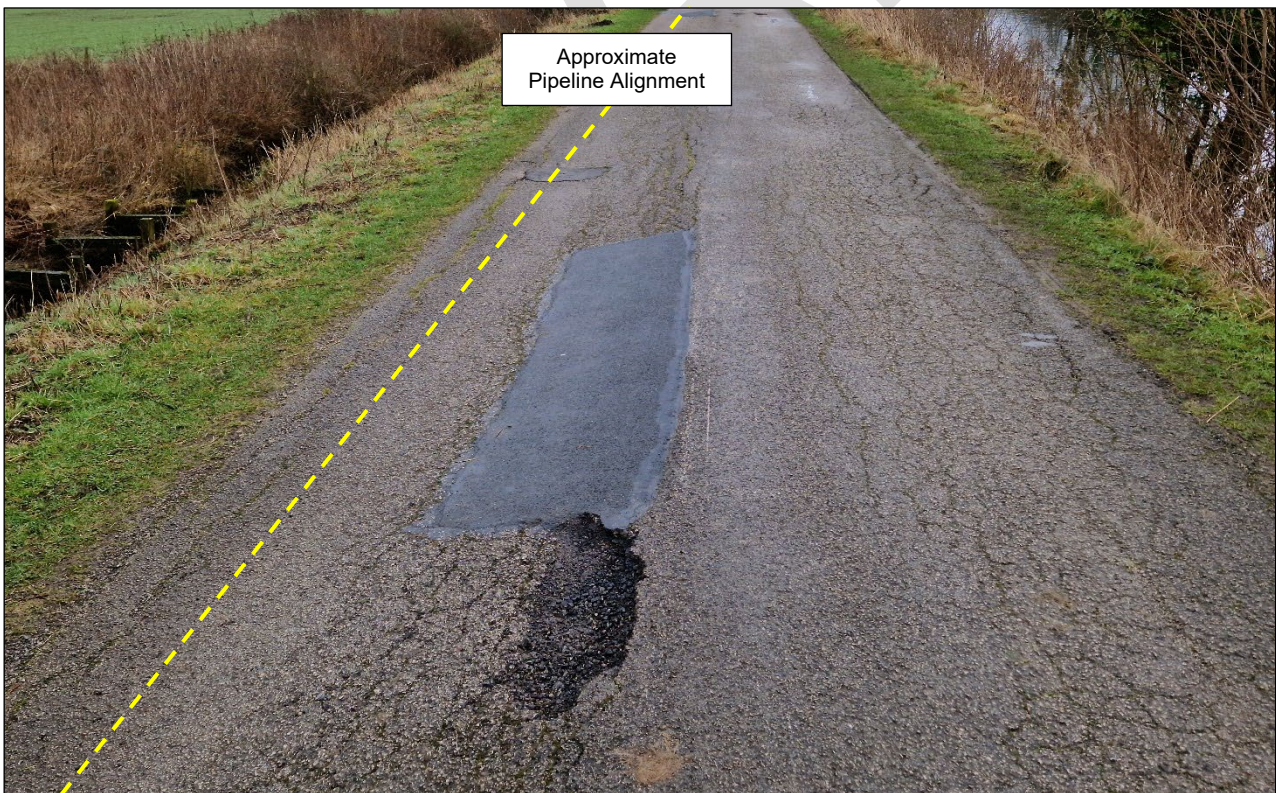
Figure 3-4 Evidence of continuing degradation and depression of the road above the pipeline

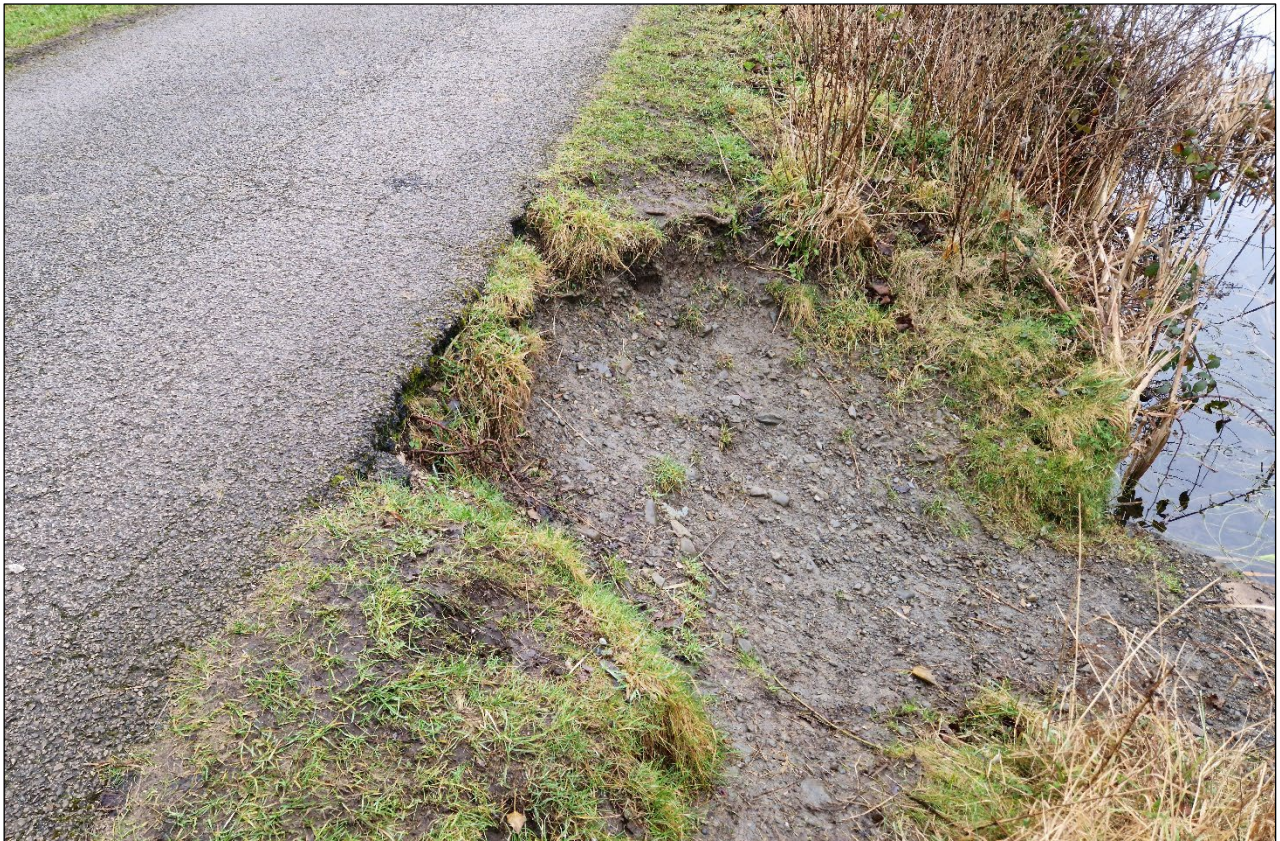
- A number of damaged areas on the canal side of the road, possibly exacerbated by vehicles (See Figure 3-5).
- At location 54.195398, -3.074255, the northern slope (grassed area) appears to show bulging in a couple of locations, with possible identifying features of a slow-moving rotational movement at one location (See Figure 3-6). This form of bulging has been previously recorded and is not expected to be a recent event.

Figure 3-5 Evidence of damage to the canal side of the road, which could lead to further localised erosion and potential undercutting of the road

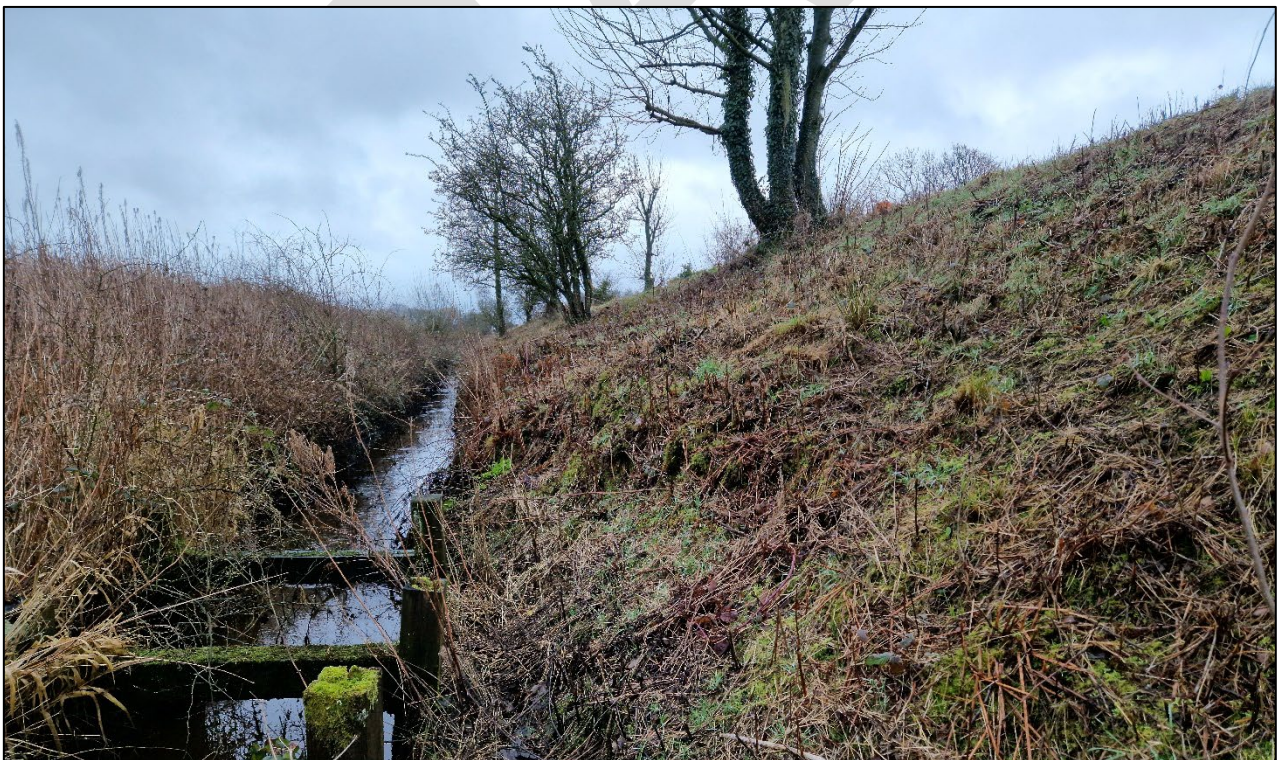
Figure 3-6 The northern slope (grassy area) appears to show bulging in a couple of locations, with possible identifying features of a slow-moving rotational movement at one location

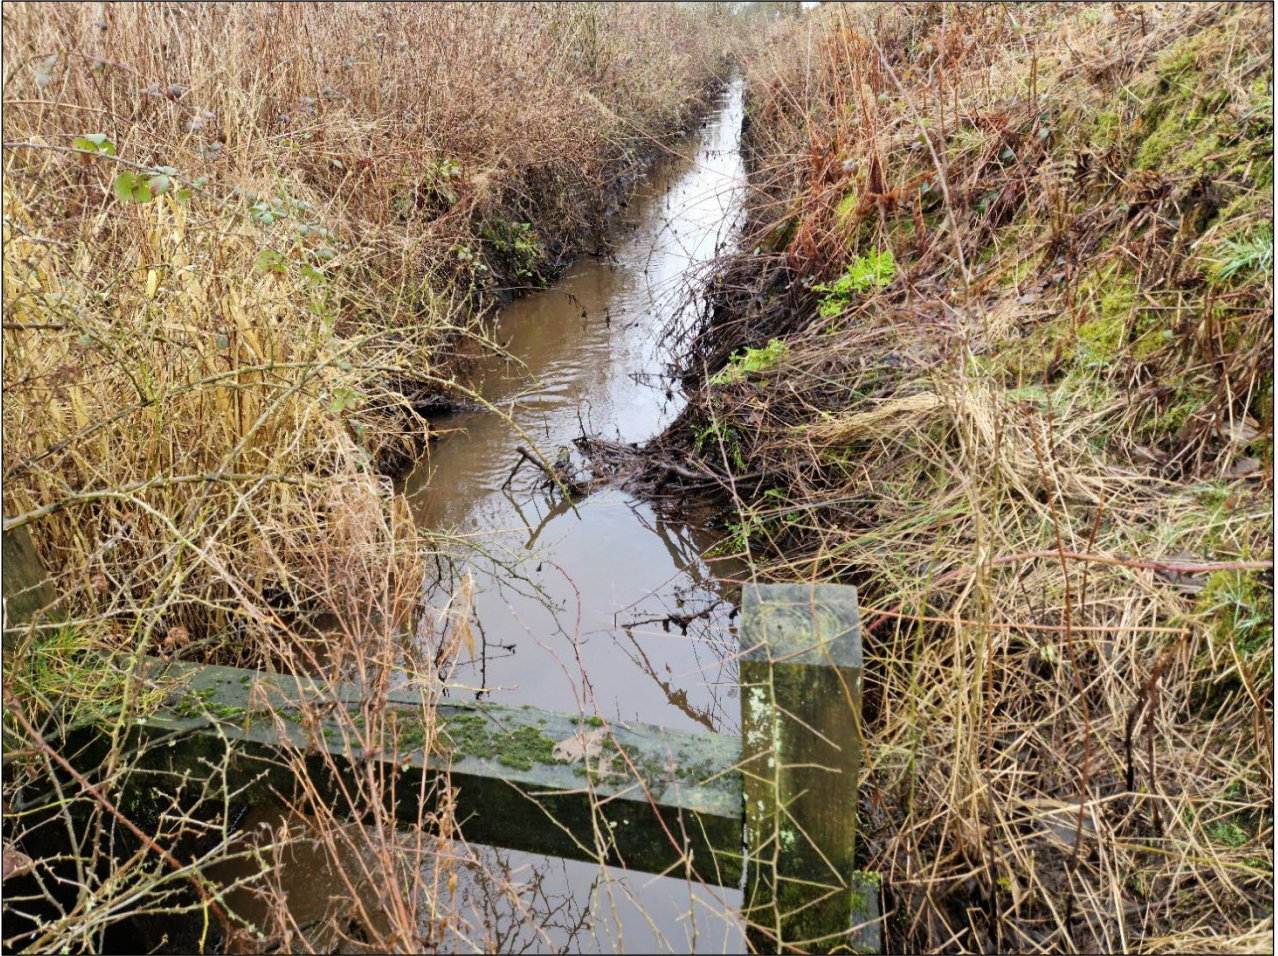
- The tidal drainage channel at the toe of the embankment (on the north side) may require some maintenance within the next 5 years. The drainage channel is stabilised using timber propping, some of which appears to be nearing end of life. Part way along the canal there is a section of propping missing entirely, which coincides with where the slope “bulging” was observed (See Figure 3-7). This suggests that the propping could positively contribute to the stability of the slope, as well as maintaining the shape and condition of the drain. The missing timber propping has been previously recorded and is not expected to be a recent event.

Figure 3-7 Section of propping missing, which coincides with where the slope “bulging” was observed (See Figure 3-6).

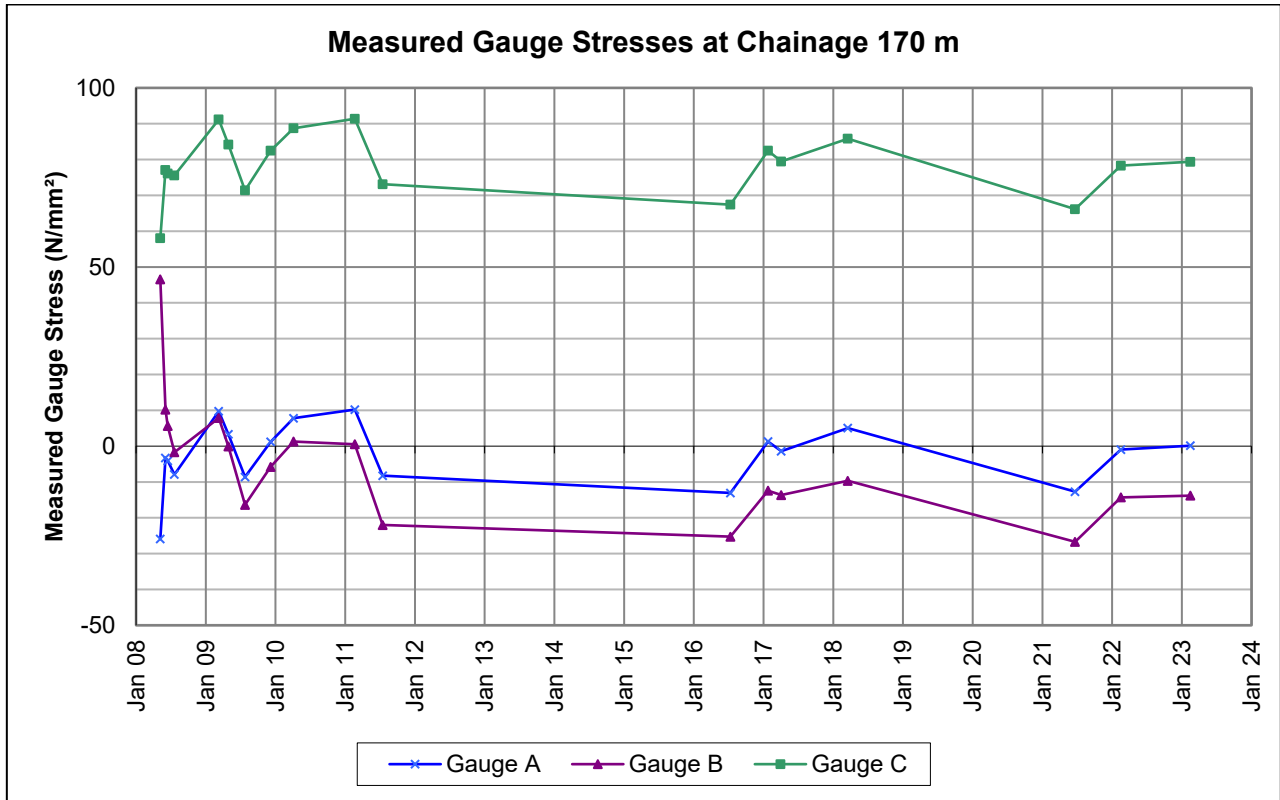
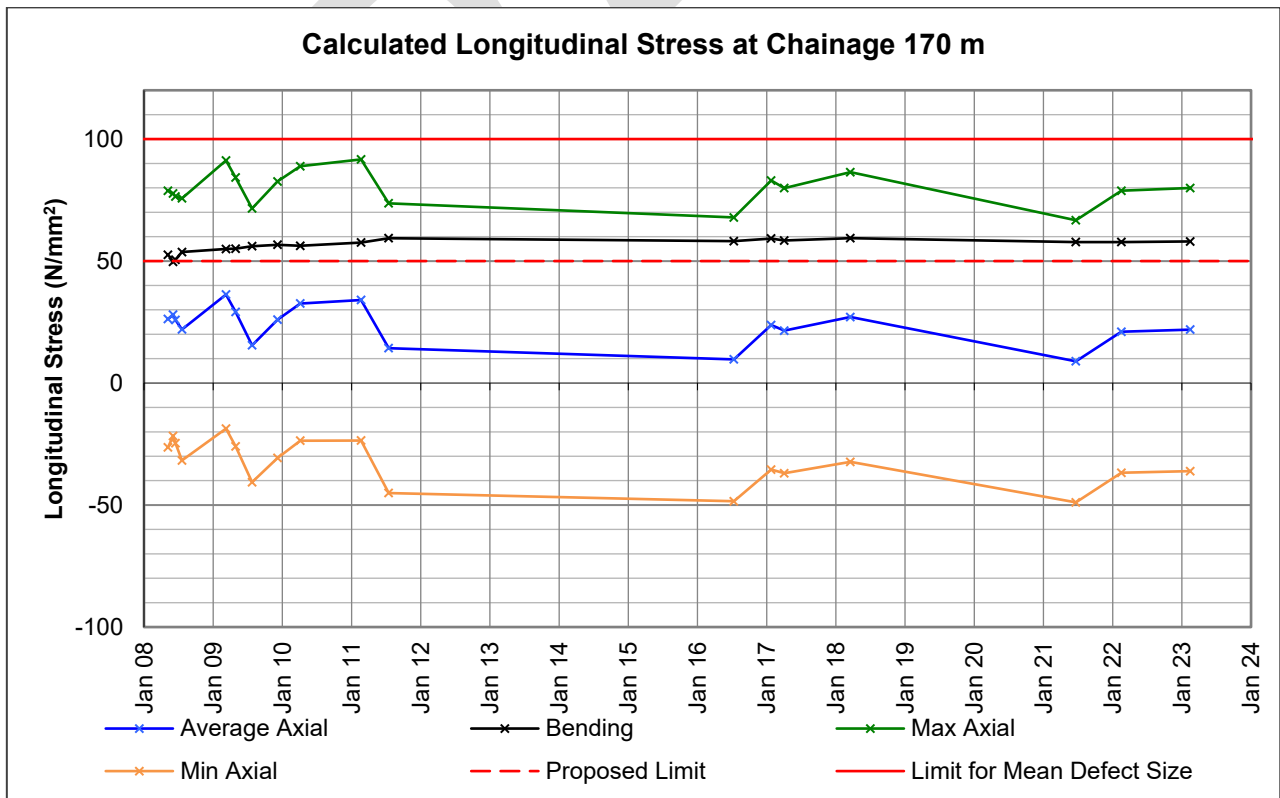
For chainage 170 m the results are within expected operational limits. The calculated bending stress of 58.0 N/mm² is within 1% of the 2022 bending stress of 57.8 N/mm², suggesting that the pipeline has not been subjected to any new loading regime within the past 12 months. The calculated maximum longitudinal tensile stress is 79.9 N/mm², which is within the upper bound limit, but above the lower bound limit; this has been apparent since the installation of the gauges and commencement of the monitoring. The calculated maximum longitudinal tensile stress is similar to previous winter months, but below the maximum recorded in February 2011 (91.7 N/mm²).

The maximum calculated longitudinal tensile stress at chainage 170 m is above the lower bound limit of 50 N/mm², but below the upper bound limit of 100 N/mm², with the current stresses similar to the previous winter readings in 2022. At chainage 570 m, the calculated longitudinal tensile stresses are above the upper bound limit of 100 N/mm², but they are still within previously recorded maxima.

2. Stresses at chainage 170 m are similar to those previously measured in winter months and is within expected operating conditions. The maximum calculated longitudinal tensile stresses are above the lower bound limit of 50 N/mm² and within the upper bound limit of 100 N/mm², although this has been apparent since installation of the gauges.

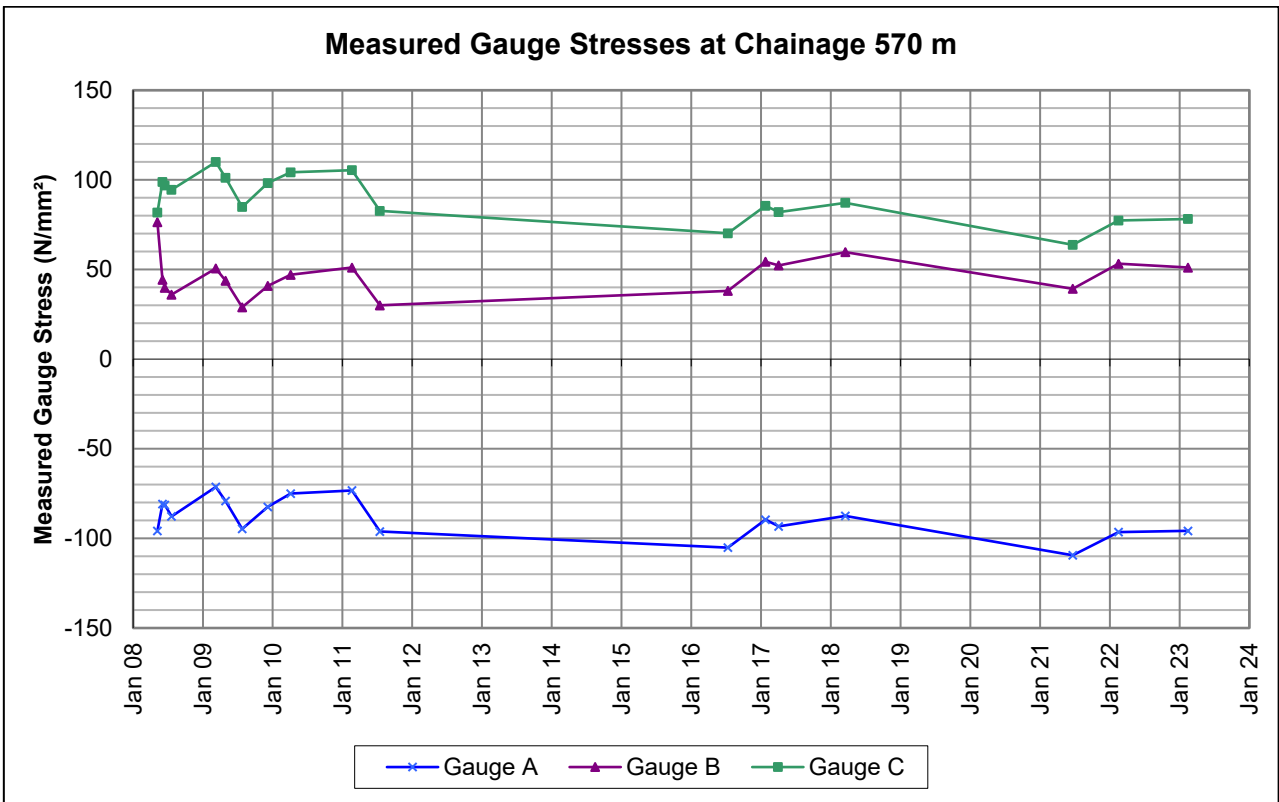
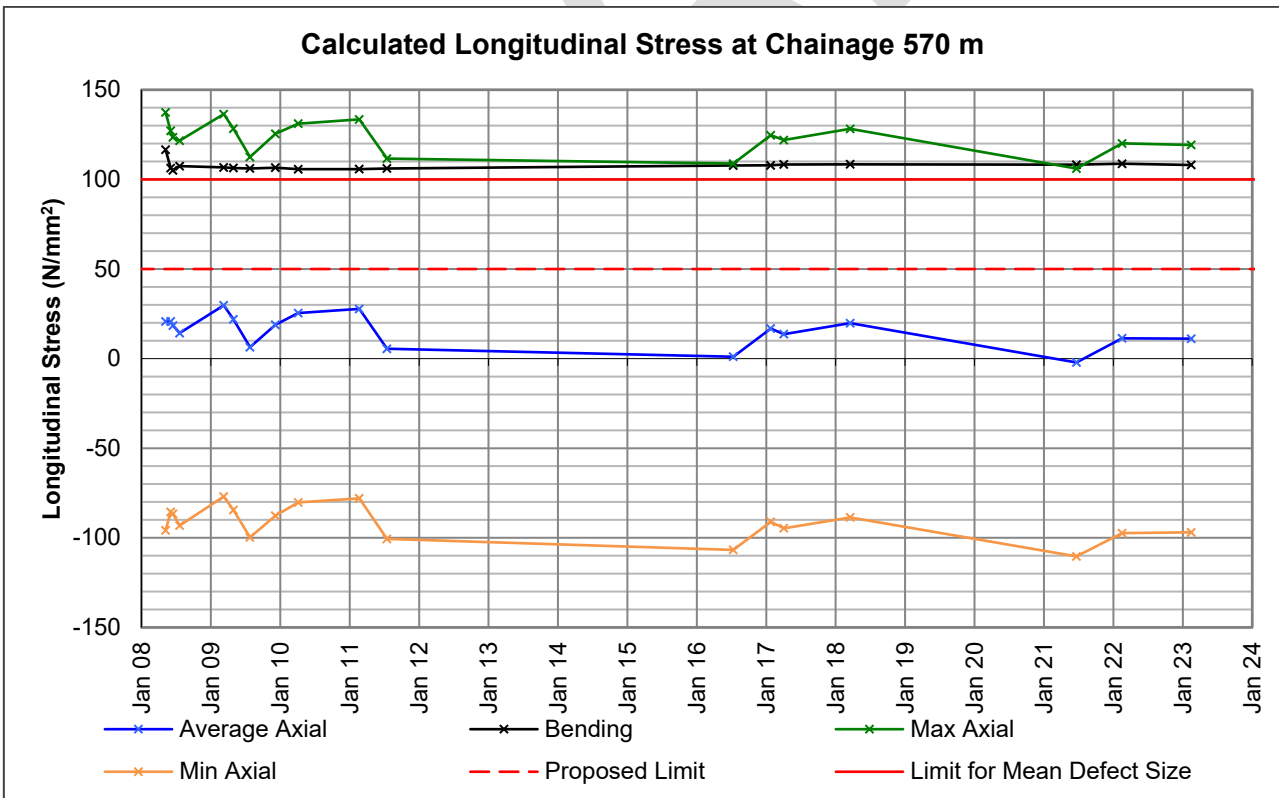
For chainage 570 m, the results are within expected operational limits. The calculated bending stress of 108.1 N/mm² is within 1% of the 2022 bending stress of 108.7 N/mm², suggesting that the pipeline has not been subjected to any new loading regime within the past 12 months. The calculated maximum longitudinal tensile stress is 119.2 N/mm², which is above the upper bound limit. However, this has been apparent since the installation of the gauges and is below the historical maxima recorded at this location.

The stress profile around the pipeline ring as shown by the gauges suggests that the pipeline is subjected to a combined lateral and hogging moment at this location, which has been apparent since installation of the gauges. However, the calculated bending stresses are currently remaining fairly consistent.

Although chainage 570 m is above the upper bound limit of 100 N/mm², this has been apparent since installation of the gauges. Based upon the individual gauges at this location, the pipeline is subjected to a lateral and hogging moment, with the lateral bending directed north (away from the canal).

3. Stresses at chainage 570 m are similar to those previously measured in winter months and is within expected operating conditions. The calculated maximum longitudinal tensile stress is 119.2 N/mm², which is above the upper bound limit. However, this has been apparent since the installation of the gauges and is within historical recorded maxima.
