ULVERSTON CANAL STRAIN GAUGES

Strain Gauge Monitoring Summary Q1 2023

Cadent Gas Limited

Report No.: 10428658/01, Rev. A

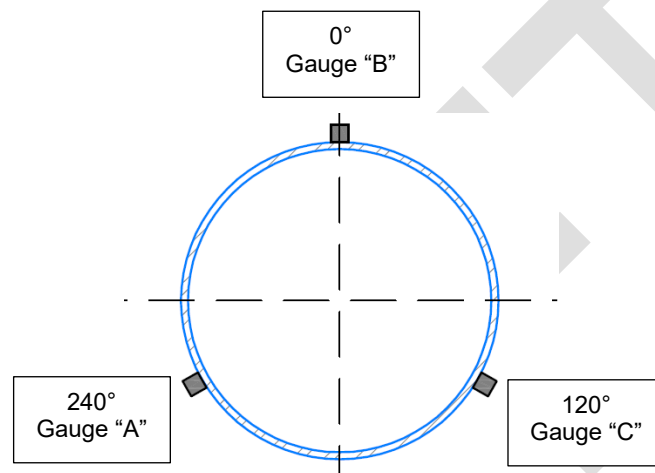
At both of these locations, three VWSG were installed onto the pipeline. The VWSG used the weldable block type, such that the gauges are mounted directly to the outer face of the pipe wall; the gauges were then wrapped under the pipeline coating upon coating repair. The three gauges are positioned at 120° intervals around the pipe circumference: at the 240°, 0° (top dead centre) and 120° positions. The orientation of the gauge positions is taken through the pipeline section, looking in the direction of flow, as shown in Figure 5-1.

Figure 5-1 Orientation of strain gauges around pipe circumference, assuming gas flow into page
